# Safety implications of Aggregated Retention harvesting

Greg Howard

Timber Training Tasmania

April 2008

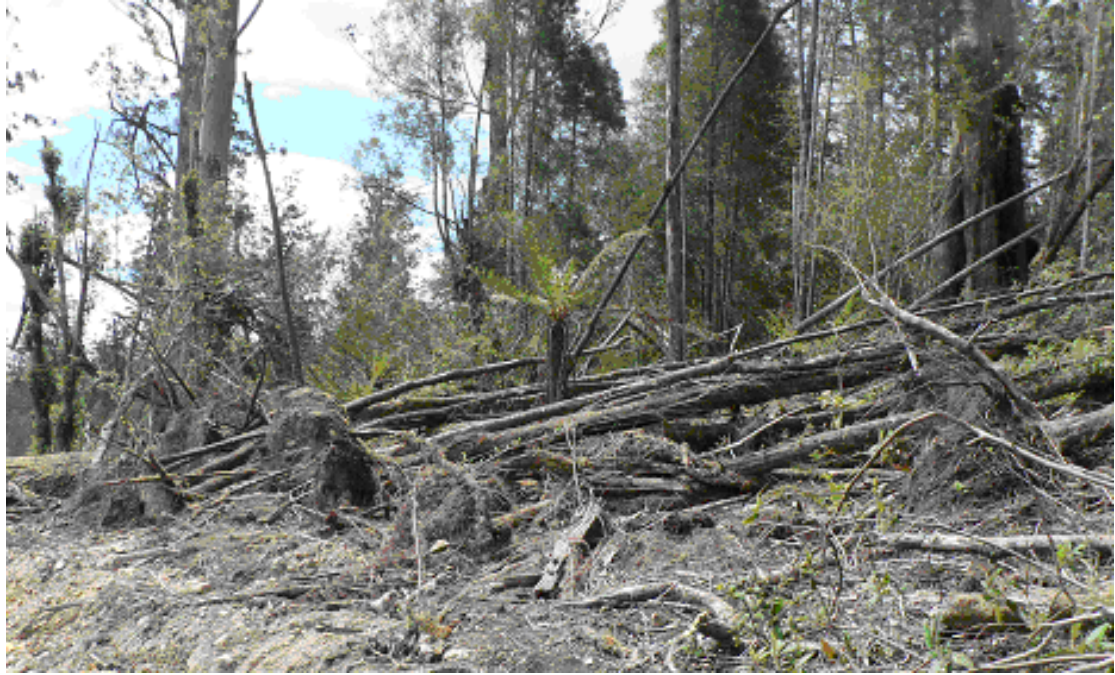
In general the smaller aggregates (those less than one hectare) were the worst affected. Some larger aggregates have sustained significant windthrow around the edges however it appears that the additional size of the aggregate has served to either absorb or deflect the wind strength therefore sparing the remainder of the aggregate (Figure 1).

Figure 1. Windthrown trees on edge of aggregate in SX018E.

- a. Wind modelling for coupes during planning.
- b. Placement of aggregates in less wind prone areas of coupes.
- c. Retained aggregates to be larger in area with no feathered edges.
- d. Incorporation of aggregates into the harvest boundaries.

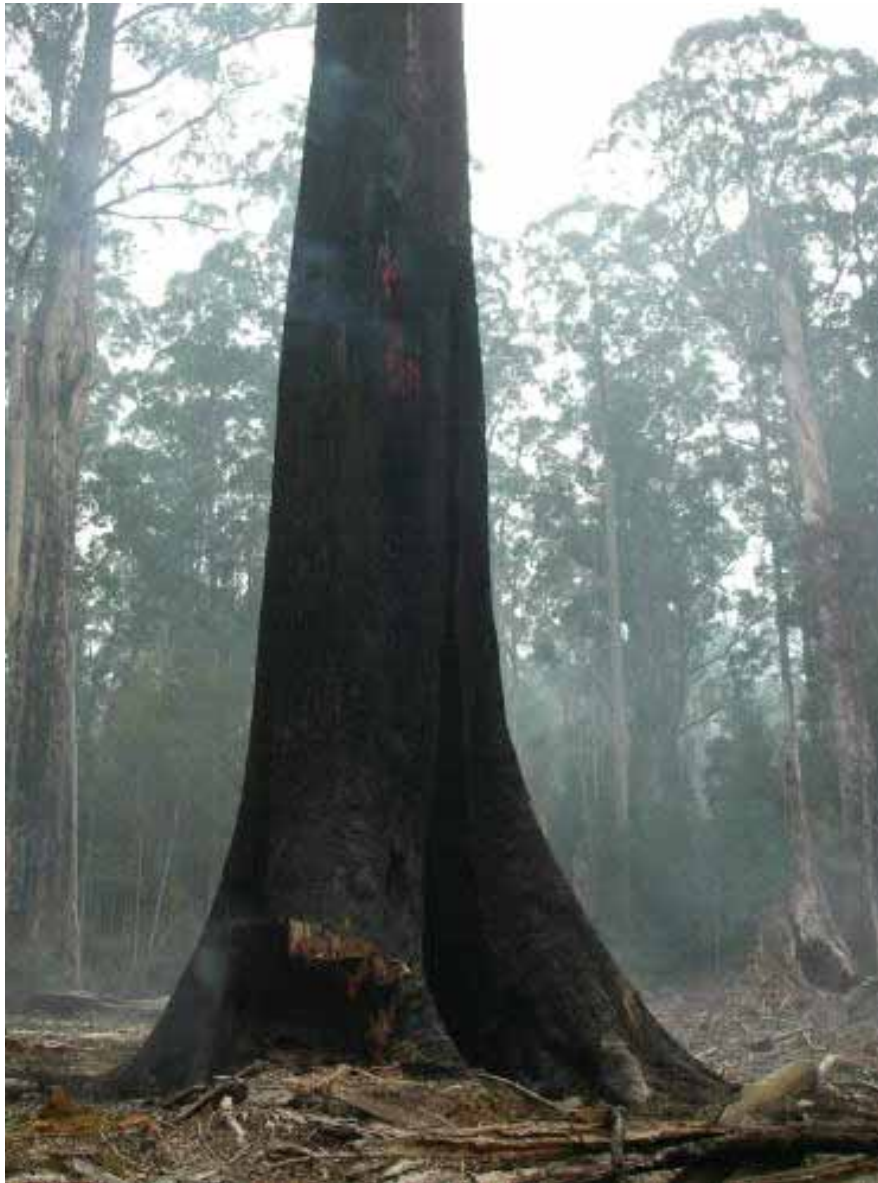
The majority of the hazardous trees are situated within the retained aggregates indicating the need for more detailed assessment of trees during the harvesting process and greater attention to burning procedures to ensure that oldgrowth trees especially do not sustain severe fire damage (Figure 2).

Figure 2. An oldgrowth tree on fire in SX018E. This tree may well subsequently die and therefore present an ongoing risk to subsequent operations.

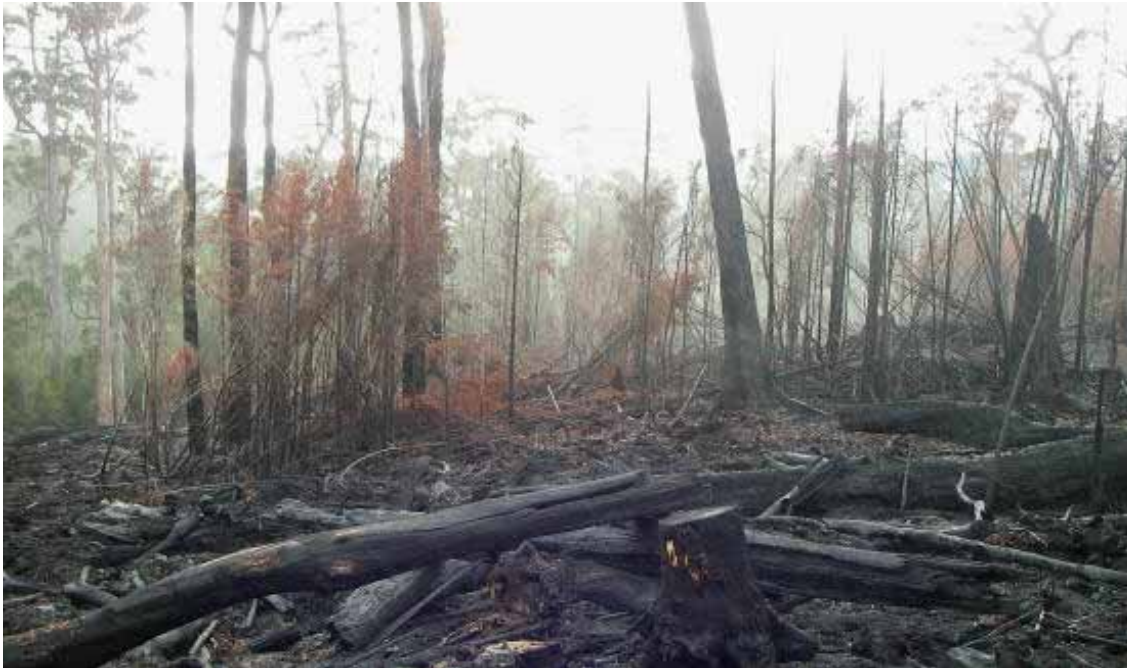
Severe burning of the retained aggregates was most common where the aggregates were smaller and contained significant windthrow (Figure 3). This result is no doubt caused by the fact that smaller aggregates would have dried out more because of increased penetration of the sunlight and the increased fuel load close to the ground caused by the windthrow. A good example of this can be seen in EP081B where the smaller aggregates in the western section of the coupe have been almost completely scorched whereas the two larger aggregates in the eastern section are almost untouched (Figure 4).

Figure 3. Severely burnt aggregate in SX007A.

- a. Coupes to be lit later in the afternoon to take advantage of rising humidity and falling temperatures.
- b. Increased use of manual lighting of coupes.
- c. Heavy fuel loads to be moved further away from aggregates on the windward side.
- d. Increased aggregate size.
- e. Reduced windthrow in aggregates.

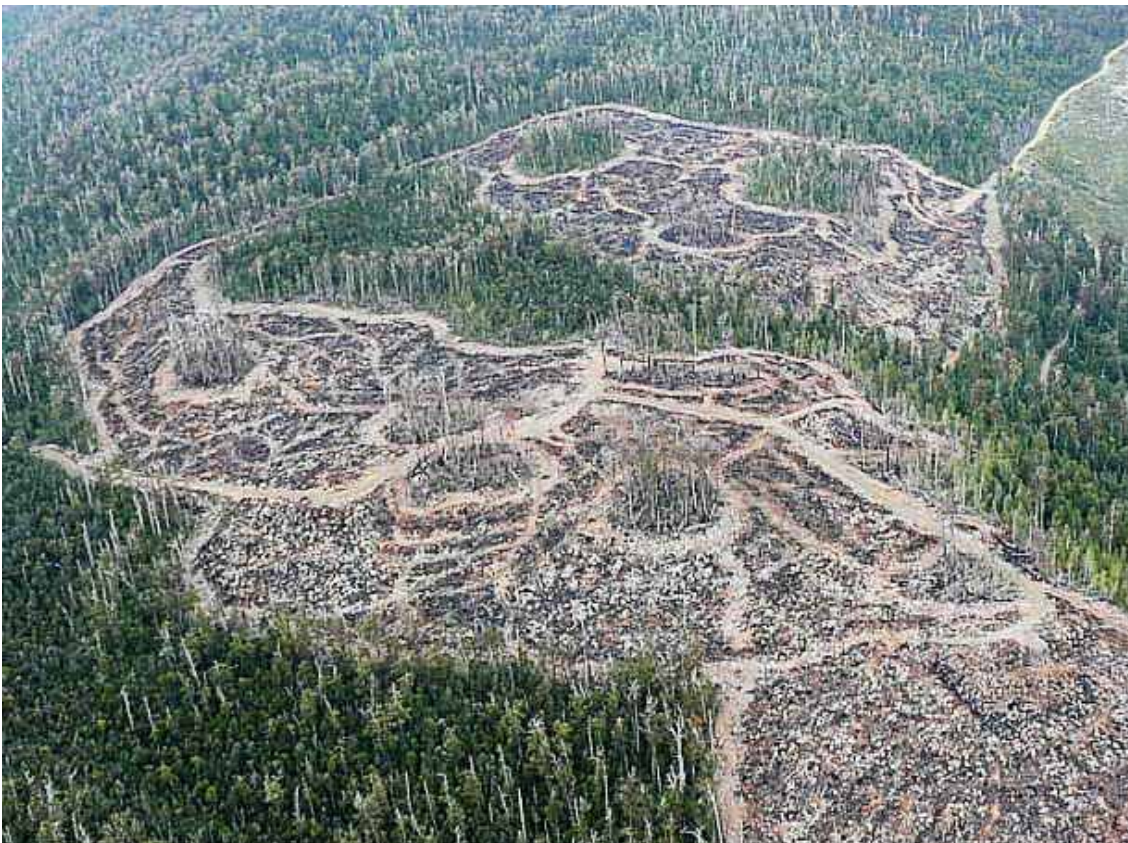
Figure 4. Results of the regeneration burn in EP081B. The six smaller aggregates in the foreground section of the coupe and the one small aggregate in the far section have sustained significant fire damage while the two larger aggregates in the far section have survived relatively unscathed.
